# MERCEDES-BENZ 2011-14 SL550

## BATTERY

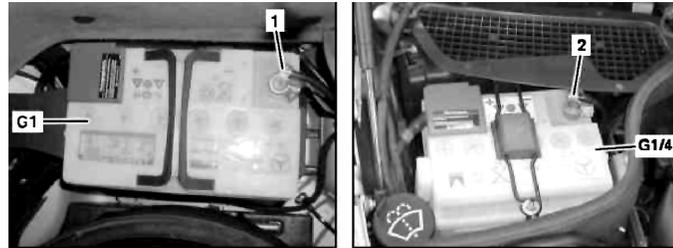
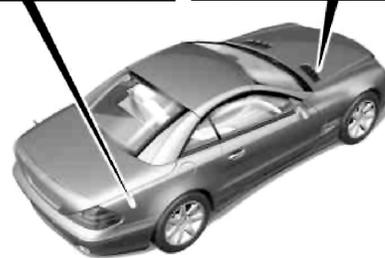
BTY120000000825

Fig. 1 Primary battery ground removal

4. Unhook trunk partition.
5. Remove spare tire cover.
6. Loosen nut, and disconnect ground line (1) from on-board electrical system battery (G1), **Fig. 1**.

7. Open engine hood and raise to vertical position.
8. Loosen nut, and disconnect ground cable (2) from starter battery (G1/4). Before disconnecting ground line (2) from starter battery (G1/4) ground line (1) must be disconnected from on-board electrical system battery (G1), otherwise components of electrical system may become damaged, **Fig. 1**.

12. Remove battery. Use carrying strap.
3. Install positive terminal cover.
4. Install bracket (4), **Fig. 2**.
5. Connect ground cable to starter battery (G1/4), **Fig. 1**. Ensure that ground line is seated tightly, otherwise terminal may be damaged.

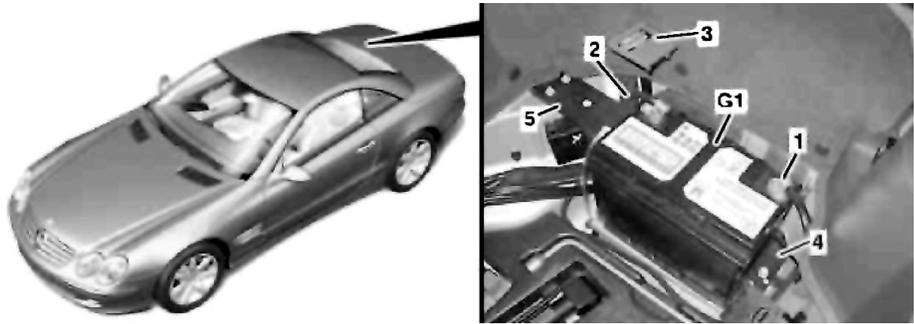
BTY120000000826

**Fig. 2 Primary battery removal**

9. Remove bracket (4), **Fig. 2**.
10. Remove positive terminal cover (3), **Fig. 2**.
11. Loosen nut, and disconnect positive lead (2) from on-board electrical system battery (G1), **Fig. 2**.

1. Insert on-board electrical system battery (G1), and push against support (5), **Fig. 2**.
2. Connect positive lead to on-board electrical system battery. Ensure that positive line is seated tightly, otherwise terminal may be damaged.

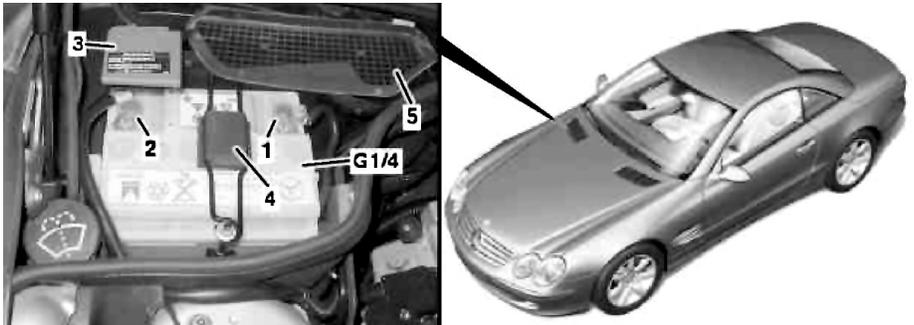
BTY120000000827

**Fig. 3 Starter battery removal**

4. Unhook trunk partition.
5. Remove spare tire cover.
6. Loosen nut, and disconnect ground line (1) from on-board electrical system battery (G1), **Fig. 1**.
7. Open engine hood and raise to vertical position.
8. Loosen nut, and disconnect ground cable (2) from starter battery (G1/4). Before disconnecting ground line (2) from starter battery (G1/4), ground line (1) must be disconnected from on-board electrical system battery (G1), otherwise components of electrical system may become damaged, **Fig. 1**.
9. Remove ventilation grille (5) on air inlet. Unclip both catch hooks on vent grille (5), **Fig. 3**.
10. Remove retaining bracket (4), **Fig. 3**.
11. Remove positive terminal cover (3), **Fig. 3**.
12. Slacken nut, and disconnect positive line (2) from starter battery (G1/4), **Fig. 3**.
13. Remove battery.

3. Install retaining bracket (4), **Fig. 3**.
4. Install ventilation grille on air inlet.
5. Connect ground cable to starter battery. Ensure that ground line is seated tightly, otherwise terminal may be damaged.
