# MERCEDES-BENZ 2005-14 SL65 AMG

## BATTERY

### Primary

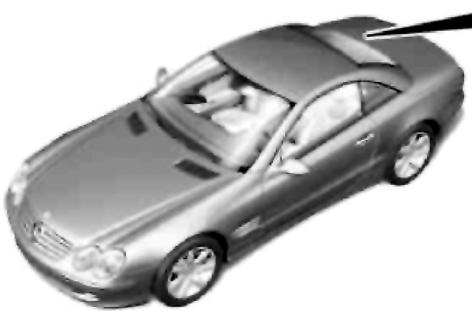
**Fig. 2 Primary battery removal. Less (P99) AMG black series**

9. Remove bracket (4), **Fig. 2**.
  10. Remove positive terminal cover (3), **Fig. 2**.
  11. Loosen nut and disconnect positive lead (2) from on-board electrical system battery (G1), **Fig. 2**.

1. Insert on-board electrical system battery (G1), and push against support (5), **Fig. 2**.
  2. Connect positive lead to on-board electrical system battery. Ensure that positive line is seated tightly, otherwise terminal may be damaged.

3. Install positive terminal cover.
  4. Install bracket (4), **Fig. 2**.
  5. Connect ground cable to starter battery (G1/4), **Fig. 1**. Ensure that ground line is seated tightly, otherwise terminal may be damaged.

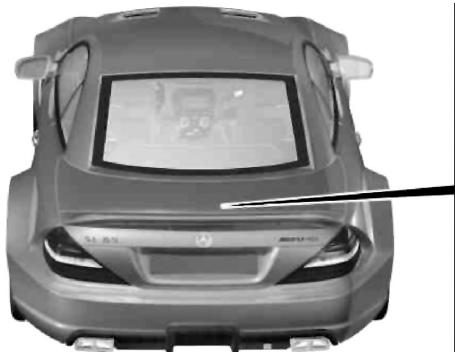
**Fig. 3 Primary battery ground removal. With (P99) AMG black series**
