# OLDSMOBILE

## 1995-2003 Aurora

### BATTERY

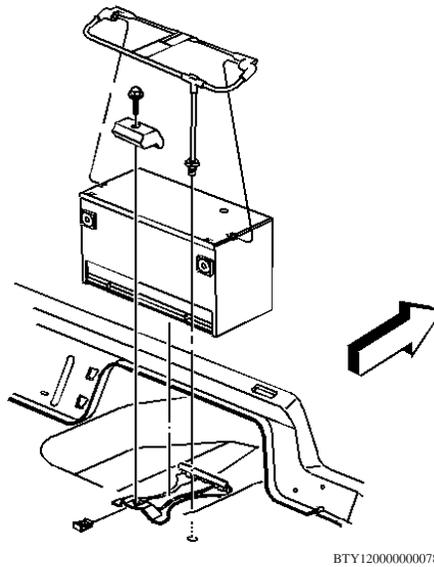
**Fig. 1 Battery removal**

1. Remove rear seat cushion.
2. Remove battery ground cable. Turn OFF ignition when connecting or disconnecting battery cables, battery charger or jumper cables. Failure to do so may damage PCM or other electronic components.
3. Remove positive battery cable.
4. Remove battery retainer mounting bolt and retainer, **Fig. 1**.
5. Remove vent tube.
6. Remove battery.

1. Install battery.
2. Install vent tube. Ensure vent tube is properly routed through floor pan grommet.
3. Install retainer and retainer mounting bolt.
4. **Torque** retainer mounting bolt to 13 ft. lbs.
5. Connect positive battery cable.
6. **Torque** positive battery cable bolt to 11 ft. lbs.
7. Connect battery ground cable.
8. **Torque** battery ground cable bolt to 11 ft. lbs.
9. Install rear seat cushion.
