DODGE 2005 Magnum

BATTERY Removal

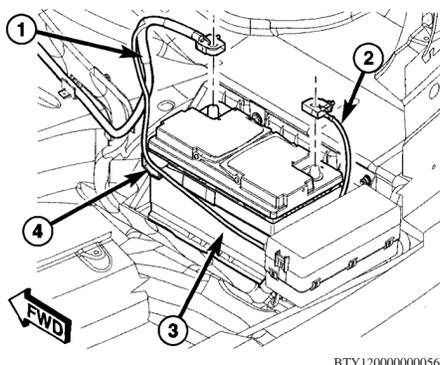
Fig. 1 Battery cable removal

1. Verify that ignition switch and all accessories are "Off."
2. Remove rear compartment floor trim panel to gain access to battery.
3. Disconnect battery ground cable (2) from battery terminal, **Fig. 1**.
4. Disconnect battery positive cable (1) from battery terminal, **Fig. 1**.
5. Unlatch battery retention strap (4), **Fig. 1**.
6. Gently disconnect battery vent tube from battery nipple, **Fig. 2**.
7. Remove bolt from battery hold down clamp and remove hold down, **Fig. 3**.
8. Remove battery from vehicle.

1. Position battery in battery tray, **Fig. 4**.
2. Install battery hold down clamp and bolt. **Torque** bolt to 35 inch lbs., **Fig. 3**.
3. Gently connect battery vent tube to battery nipple, **Fig. 2**.
4. Latch battery retention strap (4), **Fig. 1**.
5. Connect battery positive cable (1), **Fig. 1**.
6. Connect battery ground cable (2), **Fig. 1**.
7. Install rear compartment floor trim panel.

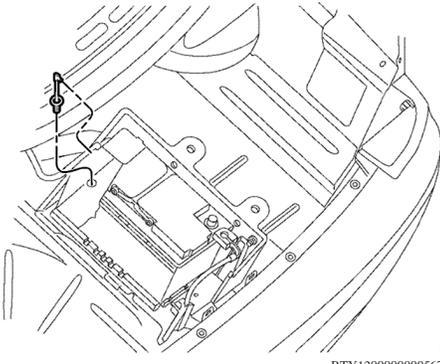
Fig. 2 Vent tube nipple location

Use care when disconnecting the battery vent tube from the battery. The vent tube nipple is made of plastic and is easily damaged if not disconnected properly.
