MERCEDES-BENZ

1998-2000 C43 AMG

BATTERY Removal

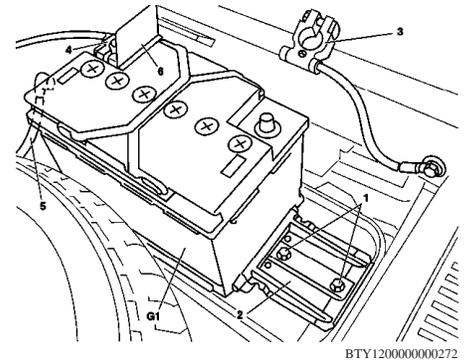
Fig. 1 Battery removal

1. Record radio anti-theft code and station presets.
2. Turn off all lamps and accessories.
3. Turn ignition switch to OFF position.
4. Fold trunk cover up.
5. Remove cargo space cover.
6. Remove mounting bolt (1) and battery hold down (2), **Fig. 1**.
7. Disconnect ground cable (3) at battery, **Fig. 1**.
8. Disconnect positive cable (4), **Fig. 1**.
9. Detach vent pipe (5) at battery, **Fig. 1**.
10. Remove battery.

1. Set battery into position.
2. Attach vent pipe (5) at battery, **Fig. 1**.
3. Connect positive cable (4), **Fig. 1**.
4. Connect ground cable (3) at battery, **Fig. 1**.
5. Install mounting bolt (1) and battery hold down (2), **Fig. 1**.
6. Install cargo space cover.
7. Fold trunk cover down.
8. Code radio as follows:
 - a. Switch on ignition switch; "CODE" will appear in display on radio.
