MERCEDES-BENZ

1998-2002 CLK320

BATTERY Removal

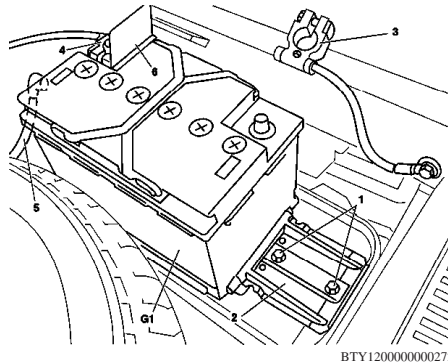
Fig. 1 Battery removal

1. Record radio anti-theft code and station presets.
2. Turn off all lamps and accessories.
3. Turn ignition switch to off position.
4. Fold trunk cover up.
5. Remove cargo space cover.
6. Remove mounting bolt (1) and battery hold down (2), Fig. 1.
7. Disconnect ground cable (3) at battery, Fig. 1.
8. Disconnect positive cable (4), Fig. 1.

9. Detach vent pipe (5) at battery, Fig. 1.
10. Remove battery.

1. Set battery into position.
2. Attach vent pipe (5) at battery, Fig. 1.
3. Connect positive cable (4), Fig. 1.
4. Connect ground cable (3) at battery, Fig. 1.

5. Install mounting bolt (1) and battery hold down (2), Fig. 1.
6. Install cargo space cover.
7. Fold trunk cover down.
8. Code radio as follows:
 - a. Switch on ignition switch, and "CODE" will appear in display on radio.
