CHEVROLET 2006-11 HHR

BATTERY

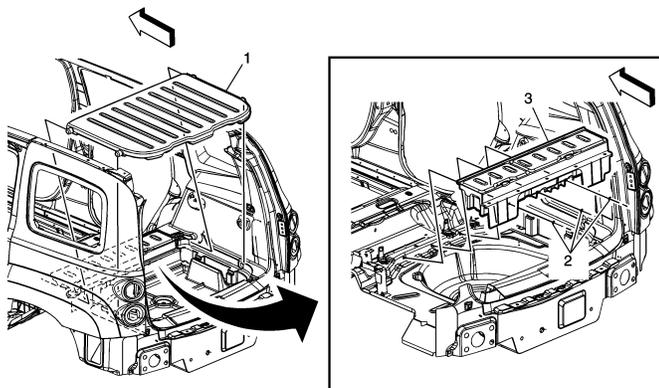
Fig. 1 Rear floor trim panel & trim plate removal

1. Record radio anti-theft code and station presets.
2. Turn off all lamps and accessories.
3. Turn ignition switch to OFF position.
4. Remove carpet on load floor rear trim panel.
5. Remove rear floor trim panel (1), Fig. 1.
6. Remove rear floor trim plate (3), Fig. 1.
7. Remove rear compartment trim panel, Fig. 2.
8. Loosen battery ground cable nut (1), Fig. 3.
9. Remove battery ground cable from battery.
10. Remove spare tire.
11. Open battery positive cable cover (2), Fig. 4.
12. Loosen battery positive cable nut (1), Fig. 4.
13. Remove battery positive cable from battery.
14. Remove battery vent tube from battery, Fig. 5.
15. Remove battery hold down retainer bolts and retainers, Fig. 6.
16. Remove battery from vehicle. Do not tip battery more than 40 degrees during removal.

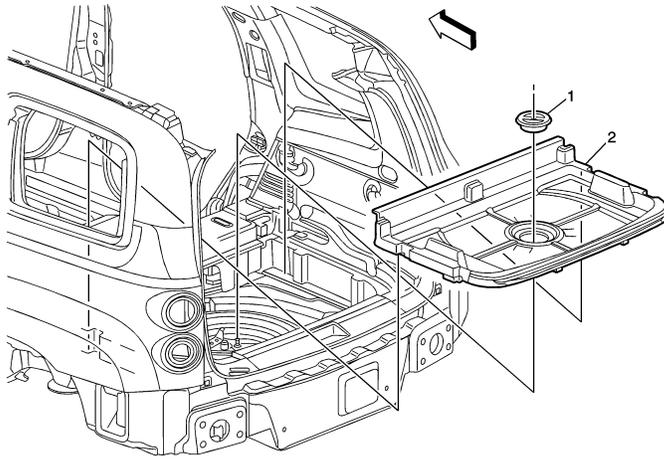
BTY120000000474

Fig. 2 Rear compartment trim panel removal

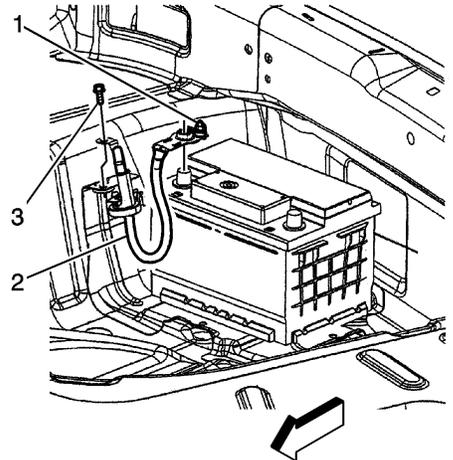
BTY120000000475

Fig. 3 Battery ground cable disconnection

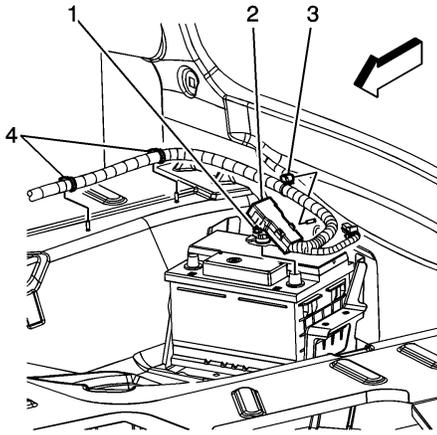
BTY120000000476

Fig. 4 Battery positive cable disconnection

1. Install battery to vehicle. Do not tip battery more than 40 degrees during installation.
2. Install battery hold down retainers and bolts, Fig. 6. Torque bolt to 18 ft. lbs.
3. Install battery vent tube to battery, Fig. 5.
4. Connect positive battery cable to battery, Fig. 4. Torque cable terminal nut to 11 ft. lbs.
5. Close battery positive cable cover.
6. Install spare tire.
7. Connect battery ground cable to battery, Fig. 3. Torque cable terminal nut to 11 ft. lbs.
8. Install rear compartment trim panel, Fig. 2.
9. Install rear floor trim plate (3), Fig. 1. Torque trim plate nuts (2) to 80 inch lbs.
10. Install rear floor trim panel (1), Fig. 1.
11. Install carpet on load floor rear trim panel.
12. Reset all preset and theft codes previously recorded to radio.

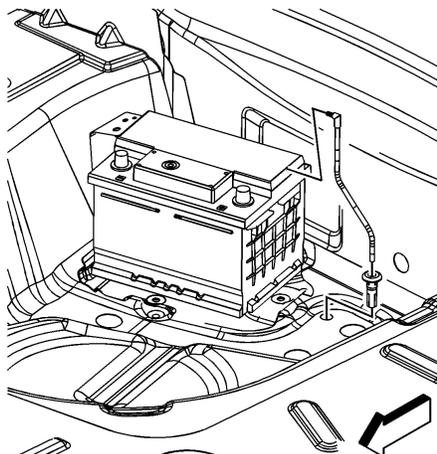
BTY120000000477

Fig. 5 Battery vent tube removal

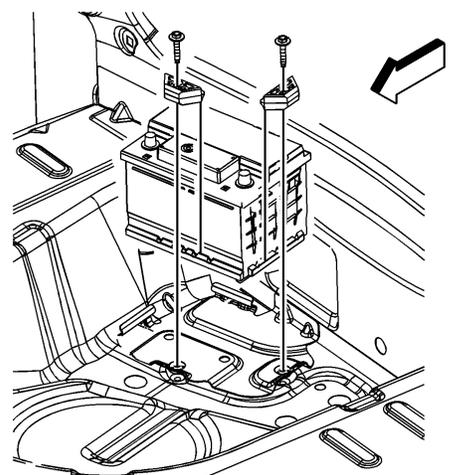
BTY120000000478

Fig. 6 Battery removal
