# MERCEDES-BENZ

## 2004 C32 AMG

### BATTERY

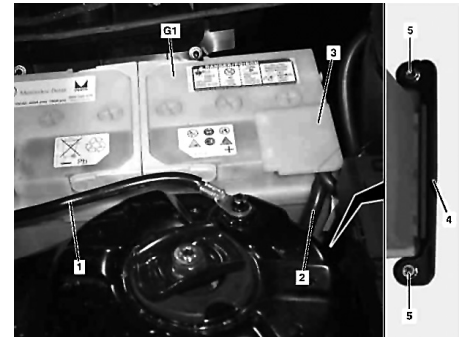
BTY120000000273

Fig. 1 Battery removal. Less P98 Black series

1. Record radio anti-theft code and station presets.
2. Turn off all lamps and accessories.
3. Turn ignition switch to OFF position.
4. Detach ground cable (1) from battery, Fig. 1.
5. Remove positive terminal cover (3), Fig. 1.
6. Detach positive cable (2) from battery, Fig. 1.
7. Remove battery mounting nuts (5), Fig. 1.
8. Remove battery mounting bracket (5), Fig. 1.
9. Remove battery.

1. Set battery into position.
2. Install battery mounting bracket (5), Fig. 1.
3. Install battery mounting nuts (5), Fig. 1.
4. Attach positive cable (2) to battery, Fig. 1.
5. Install positive terminal cover (3), Fig. 1.
6. Attach ground cable (1) to battery, Fig. 1.
7. Reset all preset and theft codes previously recorded to radio.
8. Activate steering angle sensor as follows:
  - a. Start engine and allow to idle.
  - b. Turn steering wheel from lock to lock. ADS or ESP malfunction indicator lamp should go out.
  - c. Turn ignition OFF.
9. Inspect any affected system or component such as clock, comfort adjustment, or compass for proper settings, and adjust as required.

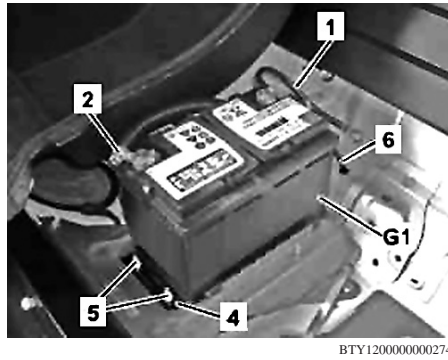
Fig. 2 Battery removal. P98 Black Series

2. Turn off all lamps and accessories.
3. Turn ignition switch to OFF position.
4. Detach ground cable (1) from battery, Fig. 2.
5. Detach positive cable (2) from battery, Fig. 2.
6. Detach vent hose (6) from battery, Fig. 2.
7. Remove battery mounting nuts (5), Fig. 2.
8. Remove battery mounting bracket (5), Fig. 2.
9. Remove battery.

1. Set battery into position.
2. Install battery mounting bracket (5), Fig. 2.
3. Install battery mounting nuts (5), Fig. 2.
4. Attach positive cable (2) to battery, Fig. 2.
5. Attach ground cable (1) to battery, Fig. 2.
6. Attach vent hose (6) from battery, Fig. 2.
7. Activate steering angle sensor as follows:
  - a. Start engine and allow to idle.
  - b. Turn steering wheel from lock to lock. ADS or ESP malfunction indicator lamp should go out.
  - c. Turn ignition OFF.
8. Inspect any affected system or component such as clock, comfort adjustment, or compass for proper settings, and adjust as required.
